# GROUND SUBSIDENCE TRIGGERED BY MINING ACTIVITY IN URBAN AND RURAL AREAS OF ALBANIA, ANALYSIS AND GEOENVIRONMENTAL IMPACTS

## ABSTRACT

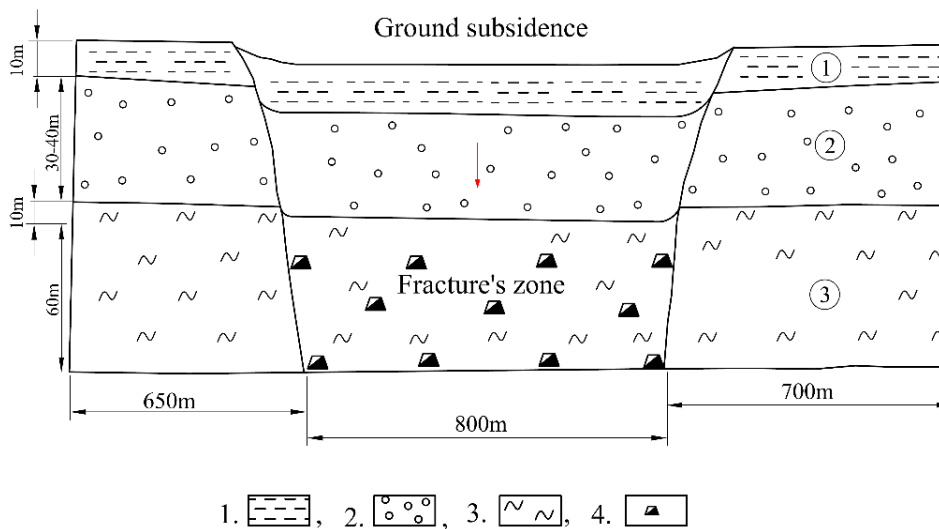
**Fig. 3:** Lithological profile of Valias mining deposit (Muceku *et al.*, 2019). **1.** Inorganic silts and clays (ML-CL); **2.** Gravel-sand-silts mixtures (GM); **3.** Claystones-siltstones rocks; **4.** Mining works.

Figure 3 depicts the three geotechnical units determined based on laboratory and field works data and the data are in the Table 1 - 3 reported.

*The geotechnical unit 1* consists of inorganic silts and clays with fine sands with low to medium plasticity (ML-CL), (ASTM 2011). These soils have stiff to medium consistency, grey and brown color. They are situated in the upper part of lithological profile and are from 10.0-12.0m up to 15.0m thick.

*The geotechnical unit 2* is represented by gravel-sand-silts mixtures (GM), (ASTM 2011), saturated, which are from dense to very dense state. It is situated below the geotechnical unit 1, and is from 30.0-35.0m to 40.0m thick.

*The geotechnical unit 3* consists of very weak rocks- claystones-siltstones rocks (Brown 1981) e.i., molasses formations making up the lower part of lithological profile.

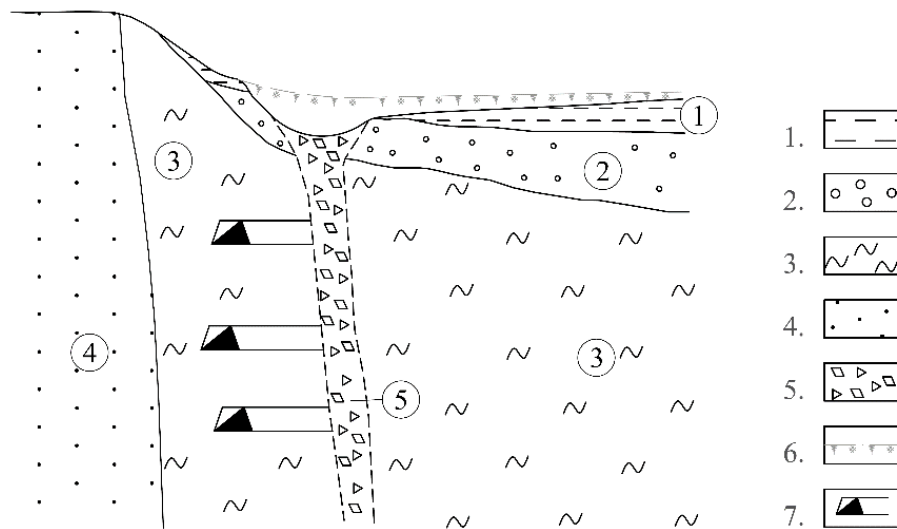
**Fig. 4:** Lithological profile of Mězezi mining deposit (Muceku *et al.*, 2019) 1. Inorganic silts and clays (ML-CL); 2. Gravel-sand-silts mixtures (GM); 3. Claystones-siltstones rocks; 4. Sandstones rocks; 5. Fracture's zone; 6. Ground surface before the subsidence occurs; 7. Mining works.

Figure 4 depicts the three geotechnical units distinguished in the Mězezi Mine area and the geotechnical properties of soil are in the Table 2 and 3 reported.

The geotechnical unit 1 consists of inorganic silts and clays with fine sands with low to medium plasticity (ML-CL), (ASTM 2011) and have the stiff consistency and are beige and brown in color. These soils could be met on the top of the lithological profile and are from 3.5-5.0m to 8.0m thick.

The geotechnical unit 2 is represented by gravel-sand-silts mixtures (GM), (ASTM 2011), which are saturated and in medium to dense state. These soils could be found below geotechnical unit 1, and are from 6.0-10.0m up to 1.0m thick.

The geotechnical unit 3 could be found in the lower part of the lithological profile. It consists of molasses formations rich in clay stones-siltstones rocks that are very weak rocks to weak rocks (Brown 1981).

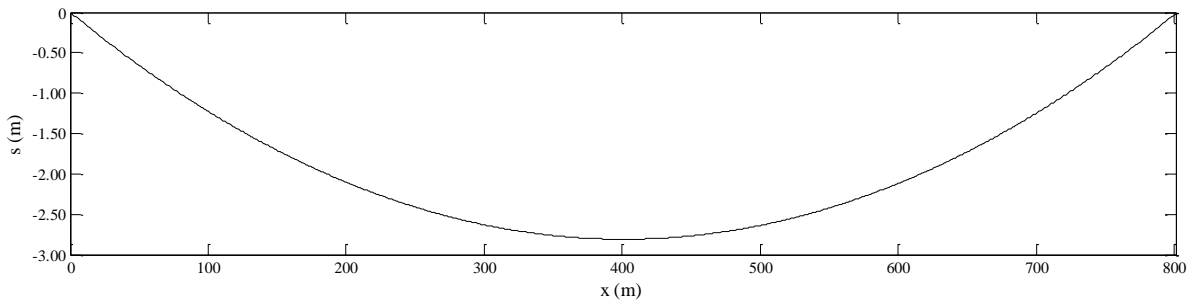
**Graph.1:** Subsidence magnitude  $s$  for Valias mine.

The greatest magnitude of subsidence is in the middle of the whole section and it is approximately 2.81 m which is in good agreement with the measurements. A similar procedure is followed for the Mëzezi mine (Graph. 2). The terrain over the exploited coal deposits has undergone a severe subsidence. The zone is from 8 to 10 m wide. In the sections where the width is 8 m, the length of the segments of the linear mesh is  $h = 1$  cm. The lamination constant is 0.55 m and  $E = 1.121 \times 10^9$  Pa. The induced stress is approximately the same. The calculations show that the maximum subsidence magnitude is 5.5 m. The sections with width 10m suffer a more severe subsidence where the predictions show that the maximum subsidence magnitude is about 8.5 m.

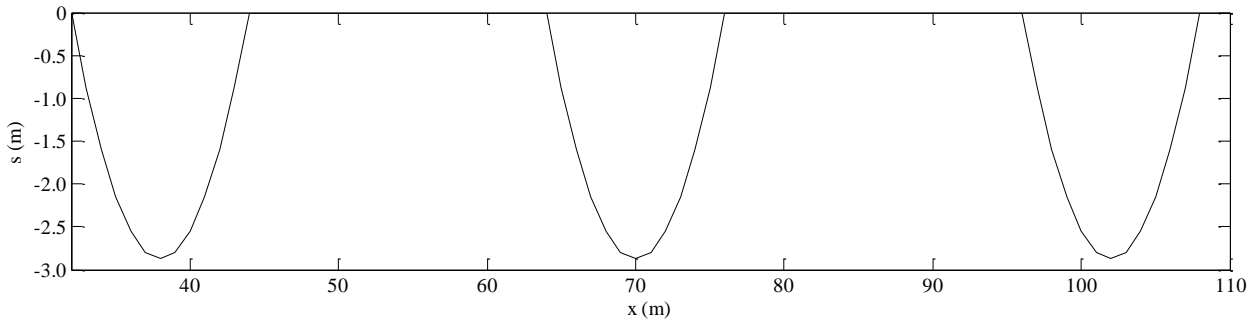
**Graph. 3:** Subsidence magnitude  $s$  for Valias mine when pillars are considered.

There is visible the effect of pillars. In the section where is present a pillar the subsidence magnitude is vanishing. In the parts where there is no pillar the subsidence magnitude reaches a maximum value of 2.9 m. The periodical character of  $s$  is extended to the whole horizontal extension. Recall that in this third case study we analyzed the subsidence in the pillars plane. This means that basically the subsidence has occurred not only in the part not supported by pillars, but even in between the pillars.

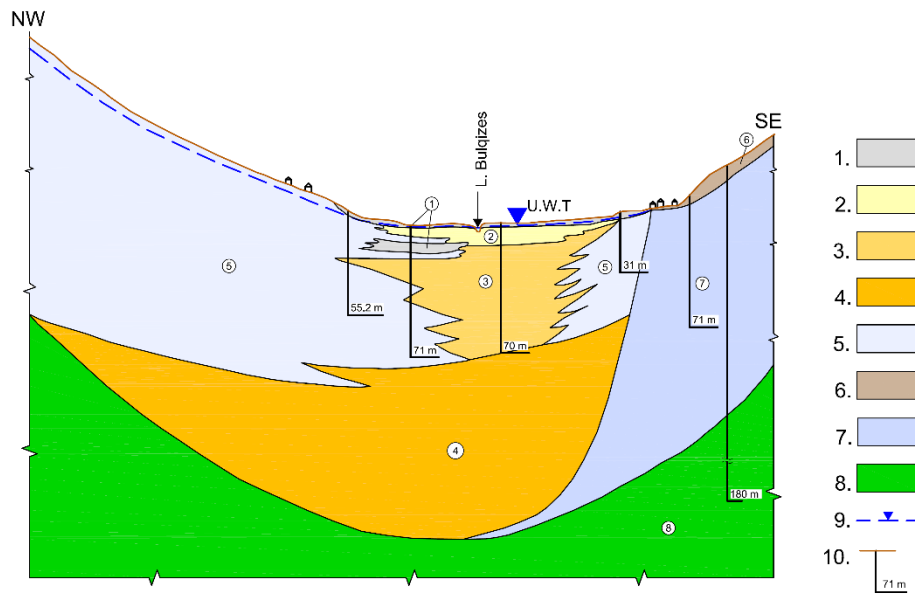
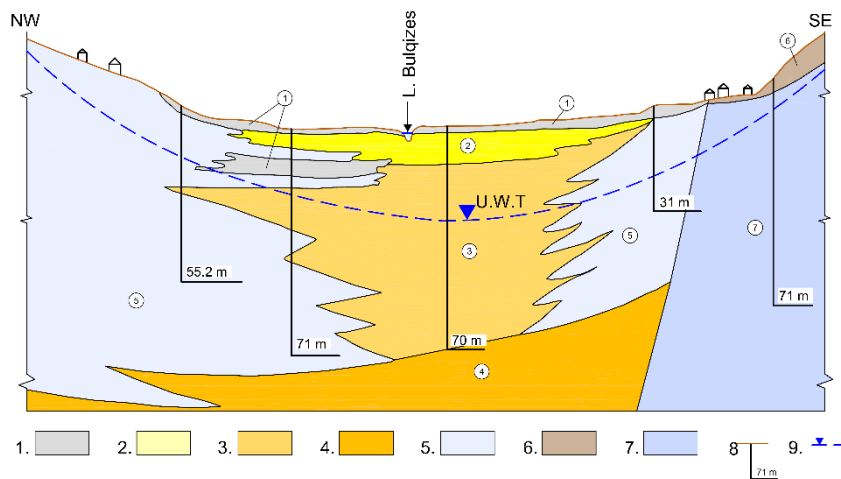
**Fig. 6:** Lithological profile of Bulqiza area (Muceku *et al.*, 2019). 1. Organic clays (OH); 2. Organic clays and silts (OH-OL); 3. Inorganic clays (ML-CL); 4. Sand-silt mixtures (SC); 5. Gravel-sand-silt mixtures (GM-GC); 6. Gravel-sand mixtures with little fines (GP); 7. Breccia rocks, 8. Ultrabasic rock; 9. Ground water table; 10. Borehole.

**Fig. 7:** Lithological profile of Bulqiza area (Muceku *et al.*, 2019). 1. Organic clays (OH); 2. Organic clays and silts (OH-OL); 3. Inorganic clays (ML-CL); 4. Sand-silt mixtures (SC); 5. Gravel-sand-silt mixtures (GM-GC); 6. Gravel-sand mixtures with little fines (GP); 7. Breccia rocks, 8. Ground water table; 9. Borehole.

The Figure 6 and 7 depict the Bulqiza's depression consisting of several soft and highly compressible soils, which are situated in the upper part of the lithological profile. These soils are represented by organic clays of medium to high plasticity (OH) and organic silt-clays of low plasticity (OL). Previous studies have shown that the underground water level in at 1995 has been + 3.5m over ground surface (underground water pressure). In 2000, the groundwater level dropped at 12.0 to 15.0m to 26.0m, below of ground surface. Consequently, land subsidence was triggered about 2.8-3.2m deep from Bulqiza flat area (Muceku and Bozo 2002), due to dewatering of compressible layers. So, the subsidence depth for each compressible layer was calculated based on geotechnical properties and formula (1). Finally, geotechnical data showed that the subsidence is totally 5.26m deep. It should be emphasized that the organic and inorganic clays-silts layers in engineering practice, are considered as problematic soils, because they take a considerable time to end the consolidation process, and it depends on load. In addition, the GPS surveys of 2018 showed that land subsidence in central part of Bulqiza has lowered by 4.2m, or 1.0m lower than in 2001 (Fig. 8). In the peripheral parts, the ground has settled from 0.1-0.2m to 0.4-0.5m since 2001 (Muceku 2002), i.e., active subsidence and ground drop to 5.8m deep in the central part.

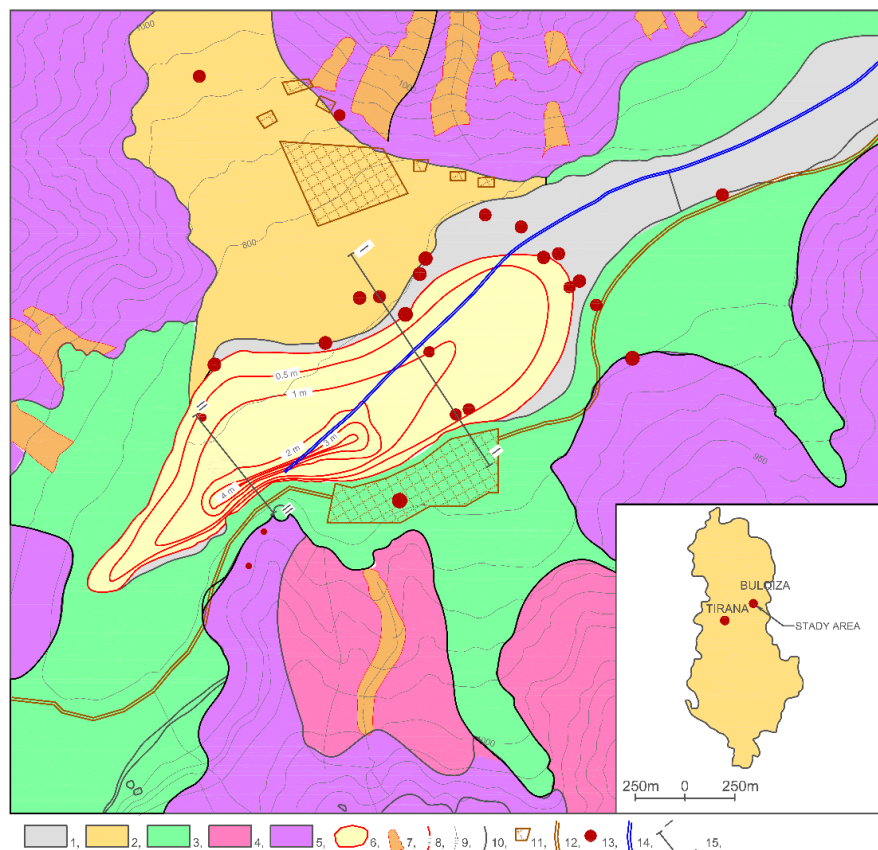
Figure 8 depicts the ground subsidence impacts in Bulqiza area found in various forms such as the tilting of building and houses, cracking of roads and buildings, changes of main course of Bulqiza stream, dried and drain the waters spring and aquifers, causing local floods. The damages due to ground subsidence in Bulqiza urban area were quite significant. Ground subsidence of about 1.51 km<sup>2</sup> occurred in the Bulqiza valley from 2000-2001. Both the primary and secondary school which is a two-storey building, a five-storey house and one-storey house were destroyed. The 0.75 km of the permanent national road of the Burreli-Pershkopia national road and the 0.62km between the new and the old Bulqiza town were cracked and settled. A small lake of about 0.14km<sup>2</sup> was created in the center of the Bulqiza flat area, flooding about 14.47 ha agricultures area. 3-4 parallel system cracks, 0.72 km long, 0.2-1.2m wide and 0.5-1.5 to 2.0m deep occurred at northern part of Bulqiza flat area. They extend from west to east in more or less parallel with the Bulqiza valleys and affected its morphology, changing it from flat area in terraced landscape. So, the ground near periphery of Bulqiza valley settled 0.2-0.7m, between first to second, second to third and third-fourth cracks. It settled 0.7-1.3m, 1.3-2.4m and 2.4-3.2m, respectively, damaging about 67 hectares of arable land. Many water springs from Bejni-Klos villages to Bulqiza town were dried due to the mining activities, affecting the landscape and the local economy. The water supply system, sewerage and drainage system of Bulqiza town were deformed and fractured.

**Fig. 8:** Geotechnical map of Bulqiza area (Muceku *et al.*, 2019). **1.** Organic clays and silts (OH-OL); **2.** Gravel-sand-silt mixtures (GM); **3.** Gravel-sand-silt mixtures (GM-GC); **4.** Breccia, moderately hard rocks; **5.** Ultrabasic, hard rock; **6.** Subsidence; **7.** Gravel-sand-silt mixtures (GM); **8.** isoline of post subsidence in meters; **9.** Topographic isoline in meters; **10.** Lithological boundary; **11.** Bulqiza urban area; **12.** Road; **13.** Boreholes; **14.** Bulqiza stream; **15.** Cross section.
