SHORELINE CHANGES ALONG ADRIATIC SEA IN ALBANIA

Neki Frashëri
Albanian Academy of Sciences

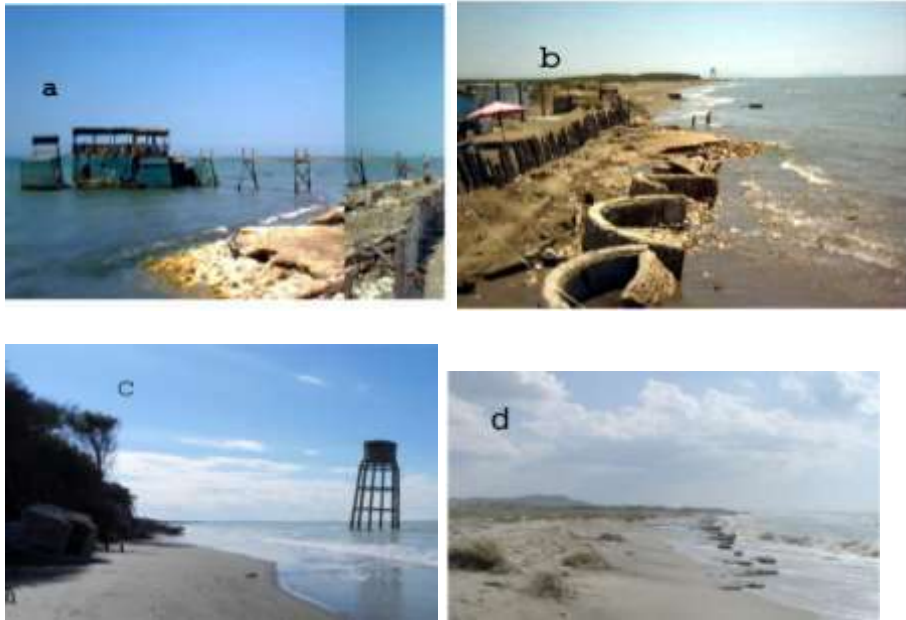
Fig.2: Semani beach: **(a)** concrete borehole basement; **(b)** beach view from the bridge; **(c)** submerged water tower; **(d)** shore abrasion in Qerreti beach.

Many papers provide information about significant sea transgression occurrences in Semani and Patoku, which have caused damage to urbanized areas. This is illustrated in Figure 2 for Semani and Patoku, respectively (Simeoni *et al.*, 1997; Pano *et al.*, 2006; Fouache *et al.*, 2010; Frasheri *et al.*, 2011a; Frasheri *et al.*, 2011b; Frasheri *et al.*, 2014; Frasheri *et al.*, 2015; De Leo *et al.*, 2016).

In Semani Beach (Fig. 2), at least two significant structures have been submerged by the sea: the basement of the deep borehole (Fig. 2a) and a water tower (Fig. 2c). The submerged concrete blocks from the "Semani 3" borehole drill equipment in Fig. 2a were repurposed as a platform for building a bar. The original height of the top basement from sea level was 5 meters (Tego 2022), with the ground level at 2 meters. As shown in Fig. 2b, viewed from the borehole bridge, there is no apparent 2-meter difference in height from sea level on the beach, as would be expected in the case of beaches subject to abrasion from sea waves. Figure 2d illustrates shore abrasion in Qerreti Beach, the southern part of Duresi Bay, north of Semani, for comparison with Fig. 2b.

Sea transgression due to wave abrasion would typically create a visible step of at least 2 meters (similar to the case of Qerreti), which is not apparent in the photo. Additionally, concrete blocks should have fallen down over the years, contrary to what has been observed.

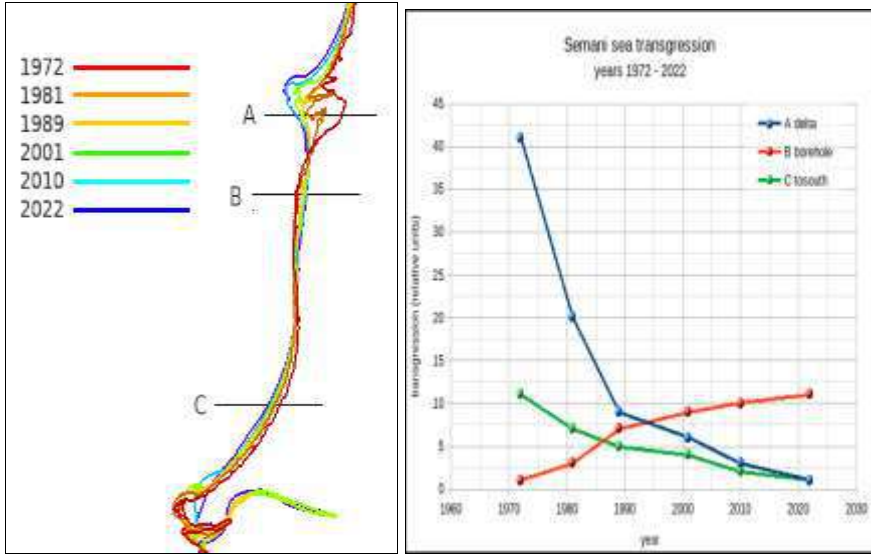
Fig.5. Profiles in Semani area: A ~ new Seamni delta, B ~ former Semani beach, C ~ beach between former Semani and Vjosa delta; and respective sea transgression chart. Relative units are image pixels (25m/pixel).

The analysis of shoreline changes over time yielded the following results. Three east-west profiles were established, cutting through the Semani delta

(A), the former Semani beach (B), and the beach between the latter and Vjosa delta in the south. Distances in pixels were measured starting from the pixel indicating the shoreline position in 1972 (Figure 5, left). The graphical representation of these distances in pixels is presented in the chart (Figure 5, right). For the former Semani beach, approximately 70% of sea transgression occurred between 1970 and 1990. The shape of the former Semani beach shoreline suggests the presence of the old Semani river delta. During the same period, there was sea regression with the development of the new Semani delta, as well as sand accumulation in the south towards the present Vjosa delta. Additionally, in one of the 1972 Landsat NIR images, a strong flow of sediment or biomass from the Semani delta towards the south is visible (Figure 1b).

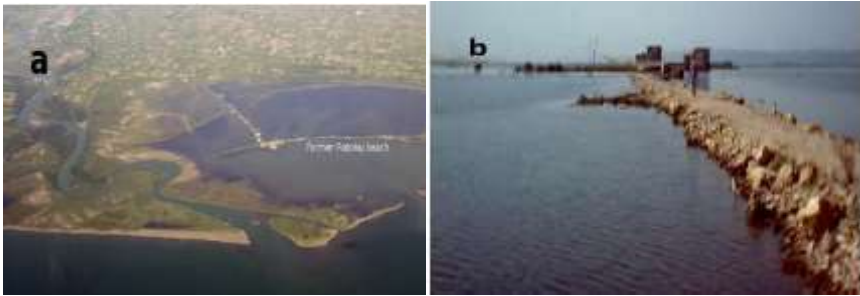
Fig.7: (a) aerial view of Patoku lagoon and Mati River delta; (b) view of submersed buildings situated in the middle of the lagoon.

Figure 6a illustrates the Patoku Lagoon. As can be clearly noted, there are old buildings from the former Patoku beach (Fig. 6b), which are now accessible through a passageway and used by fishermen. Typically, semi-enclosed coastal areas are characterized by the accumulation of sand, and the zone of the actual lagoon has been separated and protected from the sea by a line of remaining buildings that are still visible.

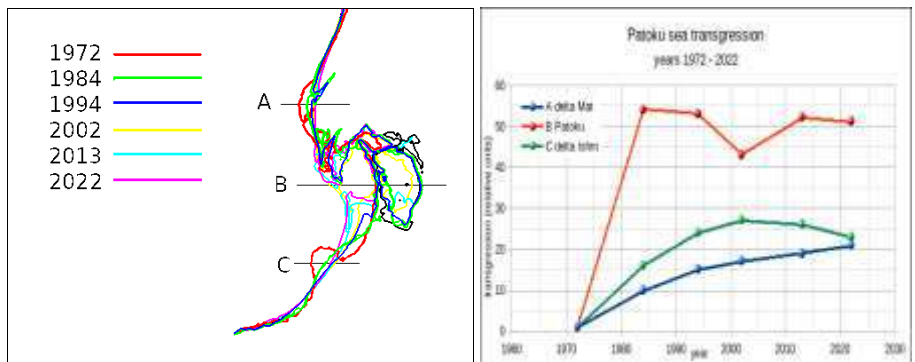
Fig.9: Profiles in Patoku area: A ~ old Mati delta, B ~ Patoku lagoon, C ~ old Ishmi delta; and respective sea transgression chart. Relative units are image pixels (25m/pixel).

In the Patoku area, as shown in Fig. 1, the following features are identified: e - Kune Vaini Lagoon, where no visible changes occurred during the period 1972-1986; d1 - delta of Mati River; d2 - Patoku lagoon, with red color indicating areas covered by sand in 1972 but submerged in later years. The analysis of shoreline variation in space and time for Patoku lagoon was based on three profiles East-West cutting through the former Mati delta (A), Patoku lagoon (B), and former Ishmi delta (C) (Fig. 7 and 8). The actual lagoon has two North-South sand dunes; on the central one, there are remains of buildings from the former Patoku beach, serving as the zero point for distance measurement in pixels. The western dune was recently formed from the Mati River (not considered in our analysis). It is observed that the internal part of the Patoku lagoon was filled with water in a short period between 1970 and 1985, with insignificant movements afterward (Fig. 9).
