## THE ROLE AND IMPORTANCE OF SURFACE WATER MANAGEMENT IN ROAD INFRASTRUCTURE ENGINEERING WORKS IN ALBANIA

**Arjol LULE and Dhurata NDREKO**

Department of Applied Geology and Geoinformatics, Faculty of  
Geology and Mining, Polytechnic University of Tirana, Albania

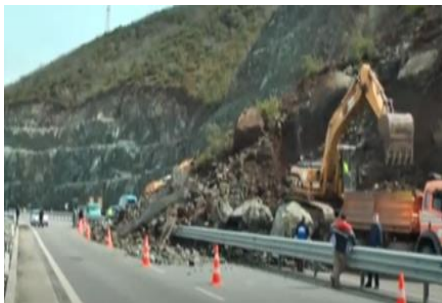
**Photo. 1:** The landslide of March 24, 2018.

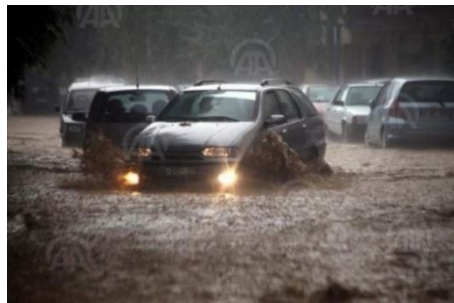
**Photo.2:** The landslide of September 07, 2014.

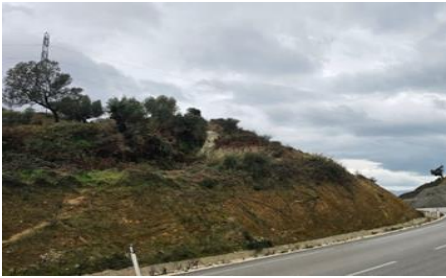
**Photo 2.** Blockage of the channel leading to water overflow onto the road

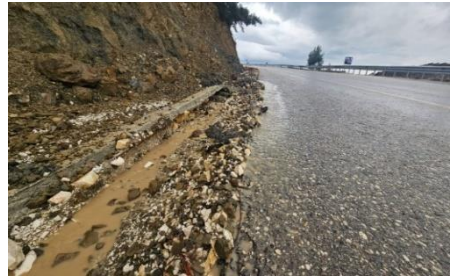
**Photo 1.** The collapse of surface water channels.
