## THE ROLE AND IMPORTANCE OF SURFACE WATER MANAGEMENT IN ROAD INFRASTRUCTURE ENGINEERING WORKS IN ALBANIA

**Arjol LULE and Dhurata NDREKO**

Department of Applied Geology and Geoinformatics, Faculty of  
Geology and Mining, Polytechnic University of Tirana, Albania

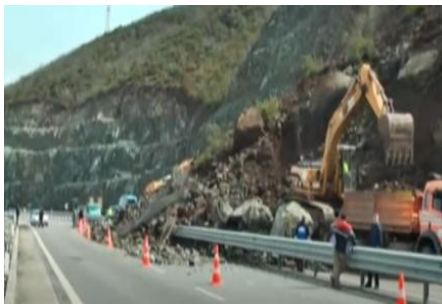
**Photo. 1:** The landslide of March 24, 2018.

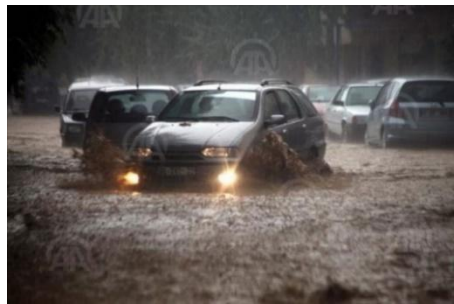
**Photo.2:** The landslide of September 07, 2014.

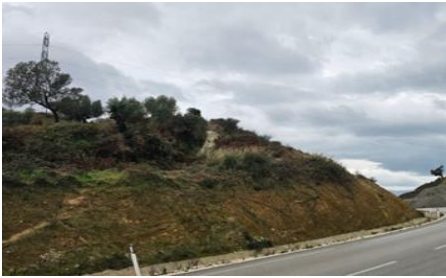
**Photo 2.** Blockage of the channel leading to water overflow onto the road

Overgrown vegetation or accumulated water on the road surface can increase slip hazards and significantly impact road traffic. The documented evidence in this study highlights the importance of routine actions in managing surface water, emphasizing the role of good engineering practices and adherence to contract standards. These measures support timely, quality interventions that reduce costs and improve road durability and safety.

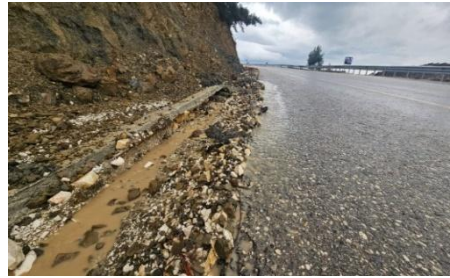
**Photo 1.** The collapse of surface water channels.
