SEISMIC ASSESSMENT OF STOCK BUILDINGS FROM THE 1960s IN KOSOVO: AN INTEGRATED ANALYTICAL AND EXPERIMENTAL APPROACH

Naser KABASHI, Enes KRASNIQI and Ylli MURATI
Faculty of Civil Engineering, University of Prishtina, Kosovo

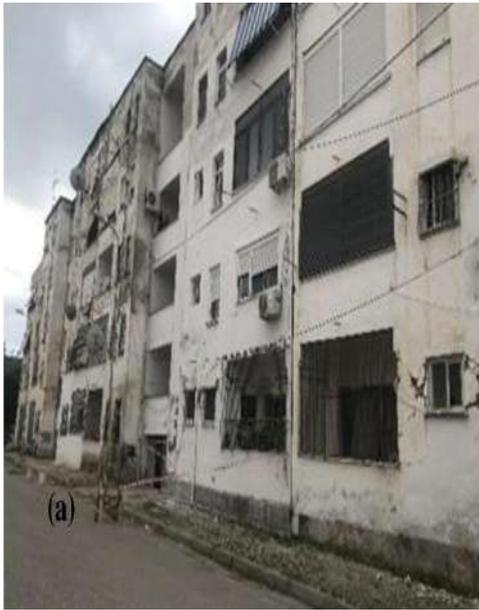
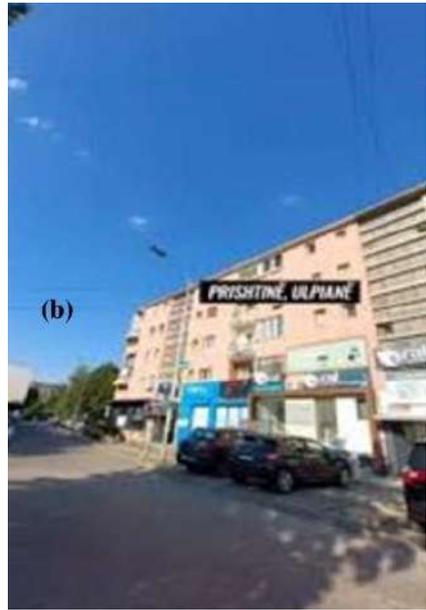
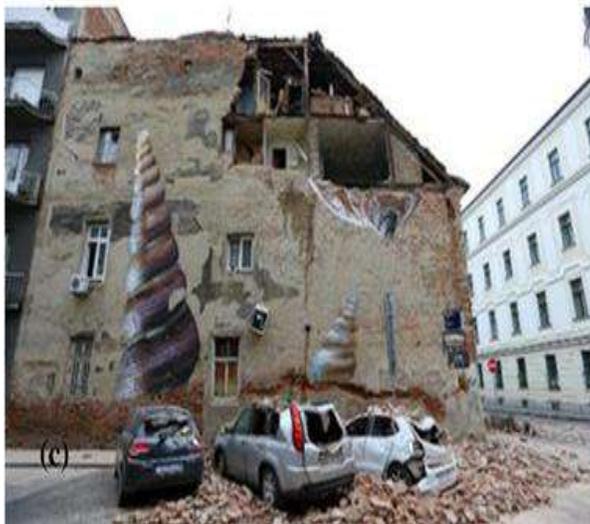
Fig. 1: (a) Behavior of buildings in Albania; (b) Buildings in Pristina; (c) Behavior of buildings in Croatia.

The study aims to establish comparability between theoretical predictions and the observed behavior of structures during recent earthquakes, such as those in Albania (November 2019) and Croatia (March 2020). The selected buildings for analysis are masonry structures from the 1960s in Kosovo, mainly in the Ulpiana–Prishtina area, as well as similar collective residential buildings up to five stories high, constructed according to the former JUS standards. As a reference, observed damage in similar structures in Albania and Croatia—belonging to the same construction category—is used for comparison, as illustrated in Fig. 1(a, b, c).

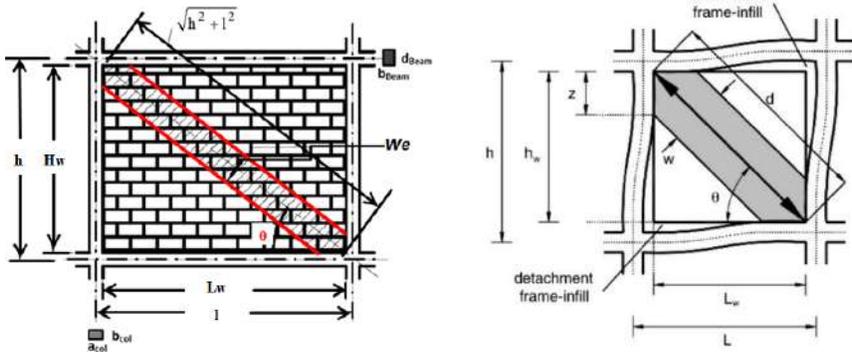
Fig. 2: The tangential sliding model of infill masonry (Paulay and Priestly, 1992).

In this model, the infill transfers most of the horizontal force along a compressed diagonal band, which is mechanically represented as a single diagonal strut with an effective width and angle. This simplified model captures the stiffening effect of the infills and their interaction with the surrounding RC frame during seismic events. A numerical modeling approach illustrating this behavior is presented in Fig. 3.

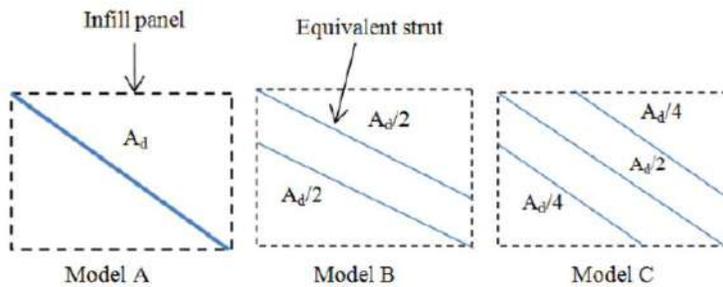
Fig. 3. Different models for the analysis of infill masonry.

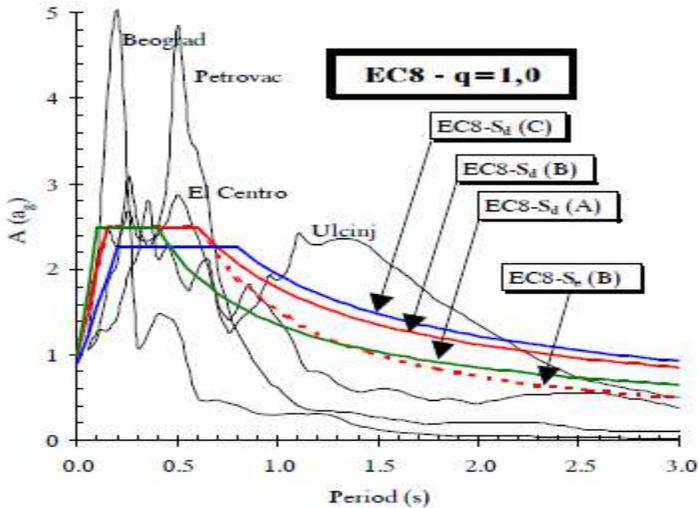
Fig. 4. Elastic acceleration spectra of earthquakes in different locations.

In the framework of structural performance assessment and analytical calculations, it is necessary not only to evaluate relative displacements but also to determine the maximum absolute displacement that may occur at a given point in time. This enables the identification of the maximum seismic force acting on the analyzed structure. To this end, several earthquake accelerograms from different countries are considered, alongside the corresponding elastic response spectra based on the EN 1998-1 standard. Figure 4 presents a comparison between real earthquake response spectra (Beograd, Petrovac, El Centro, Ulcinj) and the elastic design spectra defined by Eurocode 8 (EC8) for different soil types (A, B, C, D), using a behavior factor $q=1.0q = 1.0q=1.0$, which corresponds to no reduction for ductility.

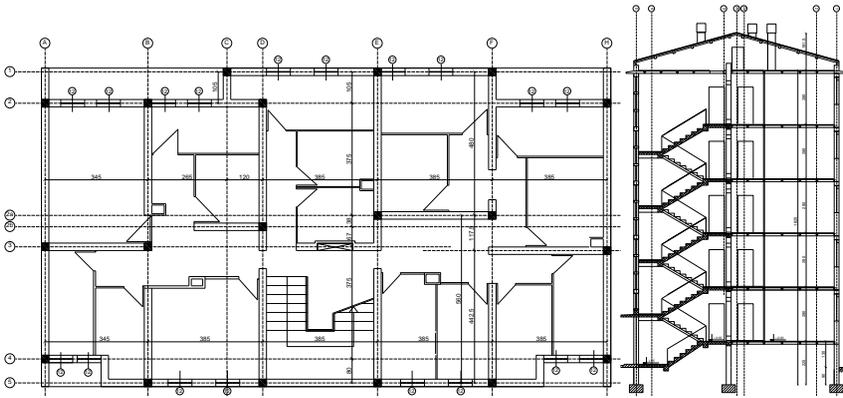
Fig. 5: Geometry of typical floor plan.

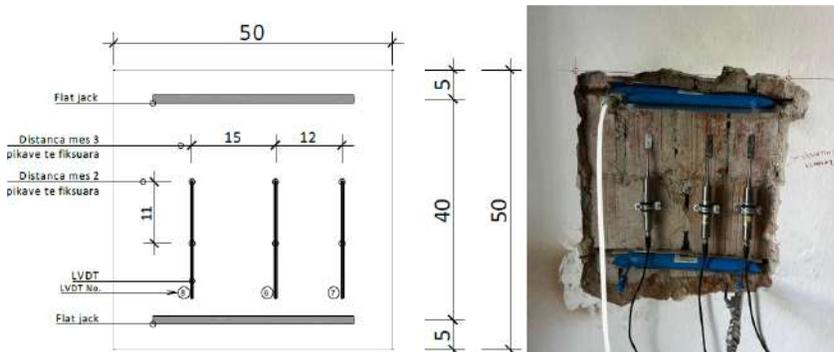
Fig. 6: Setup scheme for the positioning of the ‘Flat Jack’ device.

Flat-jack examinations were conducted on a wall at the ground-floor level to assess its mechanical characteristics as an integral component of the structure. The test results provided essential parameters for the structural analysis. An illustration of the setup is shown in Fig. 6.

The evaluation was performed after completing the necessary preparations on the wall subjected to testing, following the scheme illustrated in Fig. 6. The results of the examinations are presented in Fig. 7, incorporating the previously calibrated measurements used for the final assessments. The graph shows the outcomes of the flat-jack test, displaying the increase in stress (MPa) in relation to the measured deformation (mm/mm) for two different instruments: the average readings from the LVDTs and Strain Gauge 6. Both data sets follow clear linear trends, indicating that the masonry exhibited elastic behavior within the applied load range.

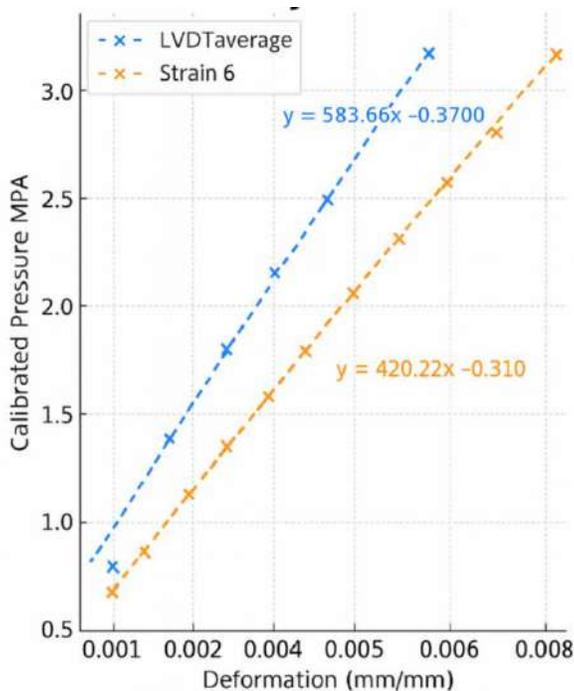
Fig. 7: The obtained results and the Pressure/Deformation ratio.

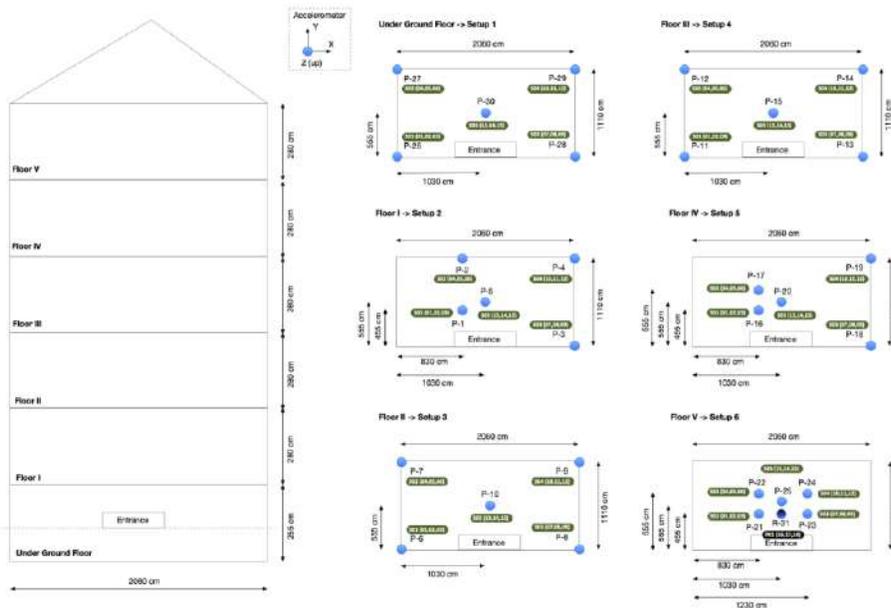
Fig. 8: Positioning positions of sensors.

and damping ratios by analyzing the structure's response to environmental excitations. Accelerometers were strategically installed on each floor, and the recorded data were processed using the Enhanced Frequency Domain Decomposition (EFDD) method. A total of eight modal shapes were identified, of which four were global modes—corresponding to movement in the X- and Y-directions and one torsional mode. These results were then used to calibrate a 3D numerical model developed using SeismoStruct and ETABS software, thereby improving the accuracy of the analyses and emphasizing the significant role of confined masonry in enhancing the structure's seismic performance. The equipment used was the Digitex AVM System, consisting of a central processing unit and multiple sensing components for data acquisition, as illustrated in Fig. 8.

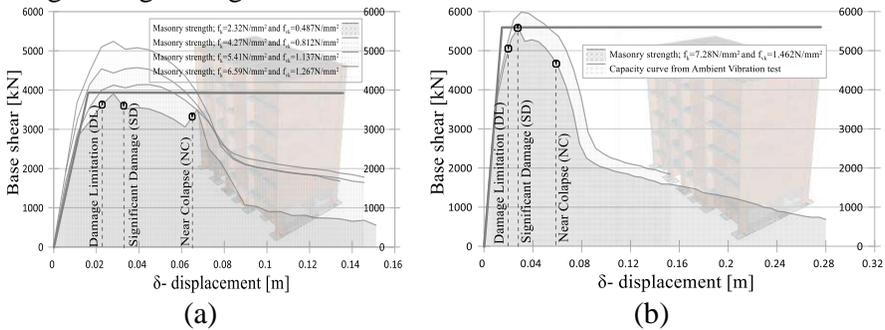
Fig. 9: Calibration of capacity curves: (a) Influence of masonry properties on structural dynamic behavior; (b) Field-test-based comparison.

The results demonstrated that the addition of confined masonry and the improvement of concrete quality significantly increased the base shear capacity and reduced displacements at the defined limit states—Damage Limitation (DL), Significant Damage (SD), and Near Collapse (NC). Specifically, the use of higher-strength masonry increased capacity by up to 40%, while the application of higher-quality concrete contributed an additional 10–15%. The calibration of the capacity curves using field-test data underscores the importance of experimental validation in the seismic assessment of existing buildings and in the development of targeted strengthening strategies.

Figures 9 and 10 provide graphical representations that help the engineer better understand how variations in masonry and concrete properties influence the shape and behavior of capacity curves. These visual comparisons facilitate the observation of how changes in material strength, stiffness, and confinement affect the structural response, thereby enabling clearer interpretation and more accurate calibration of analytical models. Similar approaches, including investigations of the influence of infill walls on the global behavior of structures, have also been studied by Santarsiero *et al.* (2021), Martin Leal-Graciano *et al.* (2020) and Moreira *et al.* (2023).

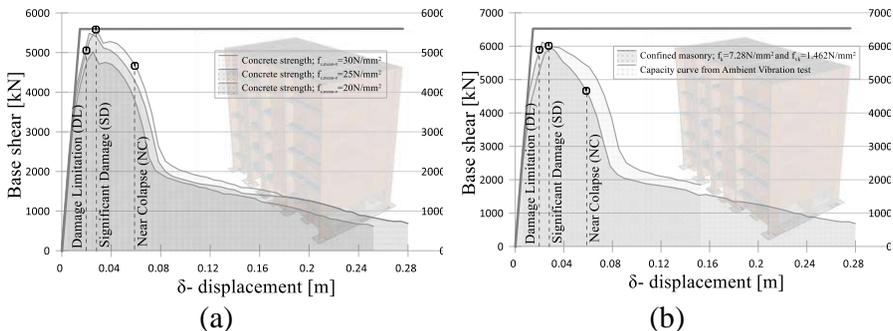
Fig. 10: Calibration process of capacity curves; (a) impact of concrete strength, (b) calibration considering confined masonry.

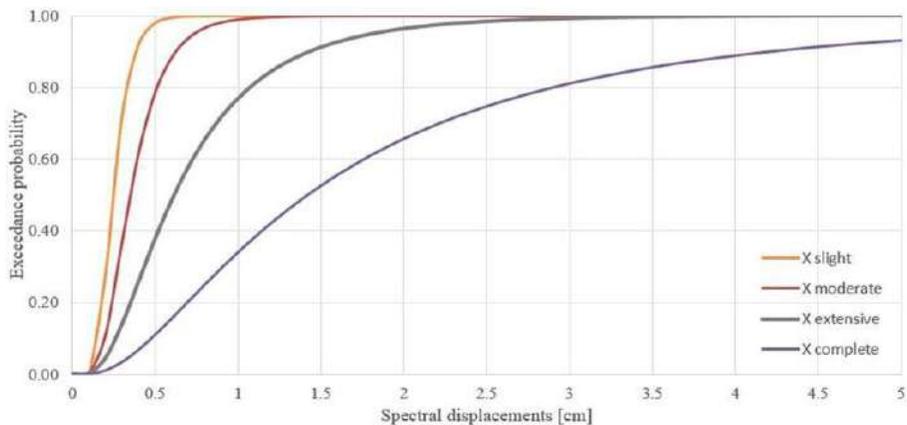
Fig. 11. Fragility curve.

Strengthening the existing building stock represents a key preventive measure for reducing earthquake-related damage, particularly in residential and public buildings. Effective and optimized strengthening interventions for existing masonry structures require a precise analysis and an accurate determination of vulnerability levels, taking into account construction typology and traditional building practices (Scupin and Vacareanu, 2023). When defining fragility parameters for various typologies—such as those analyzed through numerical models in this case study—a clear and systematic approach is necessary for selecting appropriate methodologies and materials for structural strengthening. The assessment of damage levels serves as a basis for determining spectral deformation values, which are closely connected to the probability of failure in masonry structures (see Fig. 11).

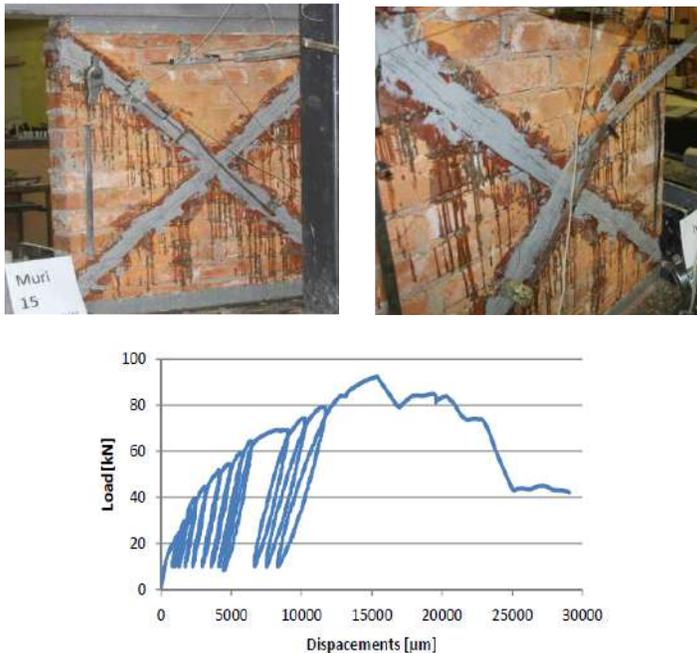
Fig. 12. a) Testing, reinforced walls. b). Displacement of the testet system.

The vulnerability of masonry structures necessitates several approaches and hypotheses for strengthening, with a focus on the application of contemporary methods and materials such as Fiber Reinforced Polymers (FRP) (Ahani *et al.* 2021). Existing structures often demonstrate seismic deficiencies and require strengthening at suitable and accessible locations (Sarker *et al.* 2011). Based on the model presented previously in Fig. 6, this study explores the use of FRP diagonal

reinforcement—as shown in Fig. 12—specifically the application of FRP strips functioning as tensile elements. These elements exhibit significant potential for improving the ductility of the structure and its individual components (Benedetti and Petrini, 1984; Kabashi *et al.* 2016; Moriera *et al.* 2023).

Figure 12 illustrates the experimental setup and results for a masonry wall strengthened with X-shaped diagonal FRP reinforcement, together with the corresponding load–displacement curve obtained from cyclic testing. The images on the left show the reinforced wall configuration, while the graph on the right presents the structural response under increasing lateral displacement, including loading cycles, progressive stiffness degradation, and peak load capacity prior to softening. Together, the visual materials provide a clear understanding of the behavior of strengthened masonry under cyclic loading and the evolution of its load-bearing capacity.
