# GROUND SUBSIDENCE TRIGGERED BY MINING ACTIVITY IN URBAN AND RURAL AREAS OF ALBANIA, ANALYSIS AND GEOENVIRONMENTAL IMPACTS

## ABSTRACT

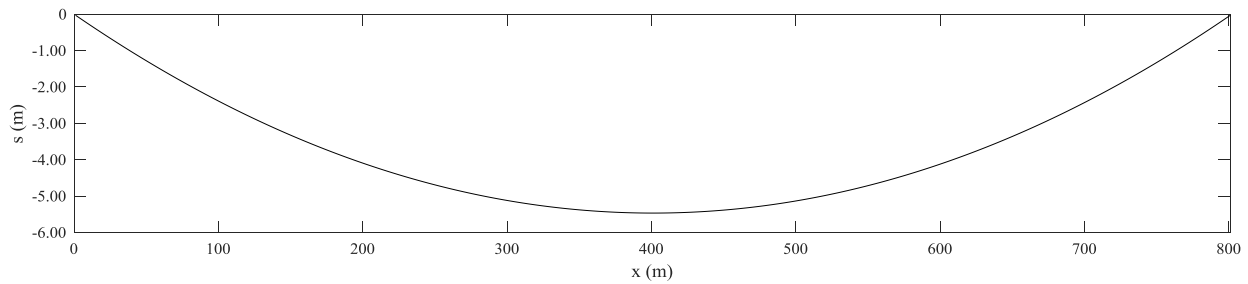
The greatest magnitude of subsidence is in the middle of the whole section and it is approximately 2.81 m which is in good agreement with the measurements. A similar procedure is followed for the Mëzezi mine (Graph. 2). The terrain over the exploited coal deposits has undergone a severe subsidence. The zone is from 8 to 10 m wide. In the sections where the width is 8 m, the length of the segments of the linear mesh is  $h = 1$  cm. The lamination constant is 0.55 m and  $E = 1.121 \times 10^9$  Pa. The induced stress is approximately the same. The calculations show that the maximum subsidence magnitude is 5.5 m. The sections with width 10m suffer a more severe subsidence where the predictions show that the maximum subsidence magnitude is about 8.5 m.

**Graph.2:** Subsidence magnitude  $s$  for Mëzezi mine.
